Manhole Inspection Summary

Manhole # S25M__023MH

Inspection ☐ Is Incomplete Rating: **4) Poor**

Location Address: **S.CAREY ST.**

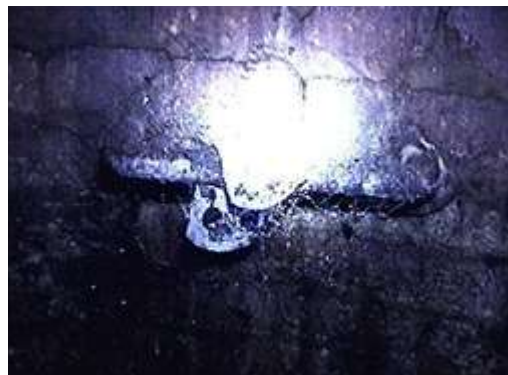
Defect 5

EVIDENCE OF SURCHARGE ON THE STEPS

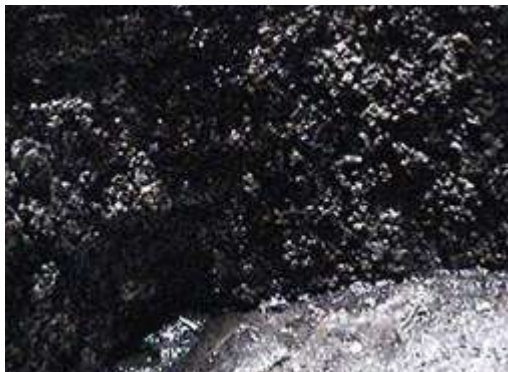
Defect 4

Condition: ☐ Sound ☐ Cracked ☐ Root Intrusion ☐ Loose Brick ☒ **Deteriorated**

Condition: ☐ Sound ☐ Cracked ☐ Root Intrusion ☒ **Deteriorated** ☐ Leaks ☐ Debris

DETERIORATED BARREL AND BENCH

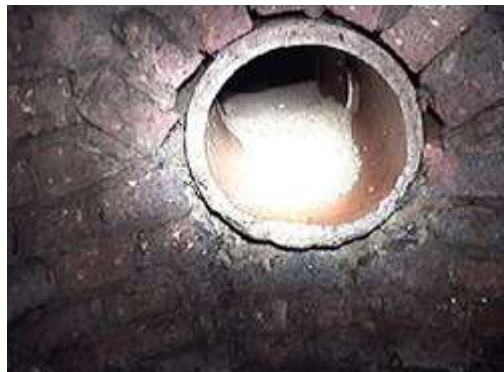
Defect 6

Condition: ☐ Sound ☒ **Cracked** ☐ Root Intrusion ☐ Loose Brick ☐ Deteriorated

corbel cracks around pipe in

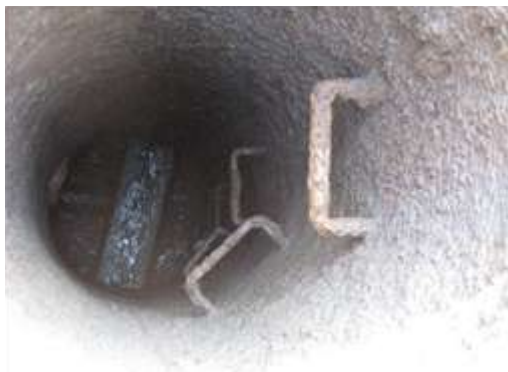
Defect 3

Count: **9** Missing: **0** ☒ **Corroded**

MUD FROM CHIMNEY TO THE BARREL
AND CORRODED STEPS

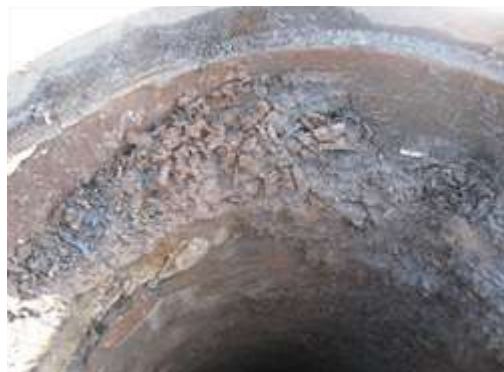
Defect 2

☒ **Evidence Of Surcharge** Depth: **5** (ft.) ☐ Active Surcharge Present

EVIDENCE OF SURCHARGE,
EVIDENCE OF INFILTRATION MUD
DESPOSITS AND CRACKED BRICK AT

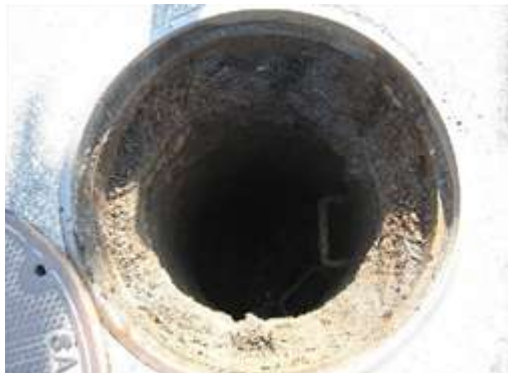
Defect 1

Condition: ☐ Sound ☒ **Cracked** ☐ Root Intrusion ☐ Loose Brick ☒ **Deteriorated**

Infiltration: ☐ None ☒ **Joint** ☐ Cracks ☐ Mortar ☐ Roots ☐ Wall

EVIDENCE OF INFILTRATION AT THE
CHIMNEY AND FRAME OFFSET

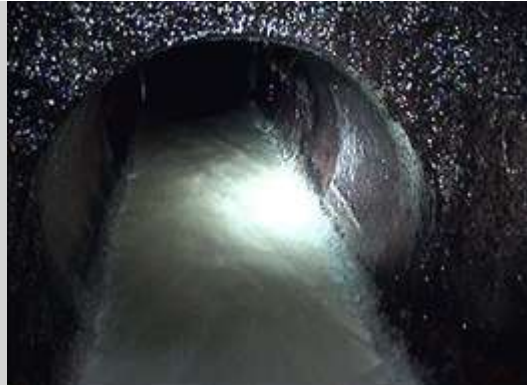
12 O'Clock Outflow

Pipe Height: **19.2** (in.) Rod and Bar (Angled)
Pipe Material: **Clay** ☐ Pipe Lined
Invert Depth: **16.00** (ft.) Flow Characteristics: **Fast**
Deposits: ☒ None ☐ Mud ☐ Sludge ☐ Debris ☐ Grease
Silt Depth: **0** (in.) Deposits Extent:
Infiltration: **Evidence** Pipe Seal Cond: **Unknown**

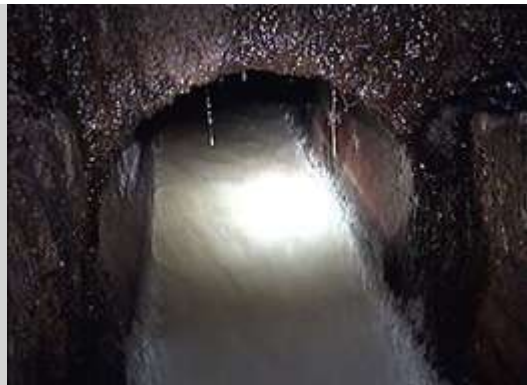
6 O'Clock Inflow

Pipe Height: **21.6** (in.) Rod and Bar (Angled)
Pipe Material: **Clay** ☐ Pipe Lined
Invert Depth: **16.00** (ft.) Flow Characteristics: **Fast**
Deposits: ☒ None ☐ Mud ☐ Sludge ☐ Debris ☐ Grease
Silt Depth: **0** (in.) Deposits Extent:
Infiltration: **Evidence** Pipe Seal Cond: **Unknown**

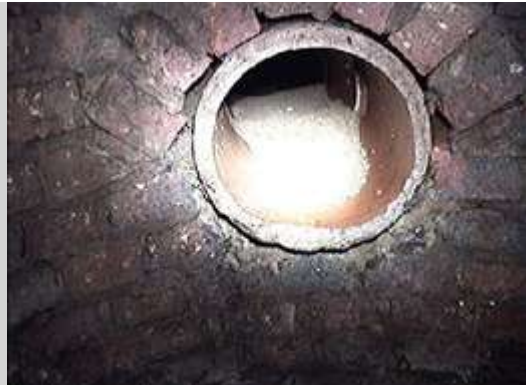
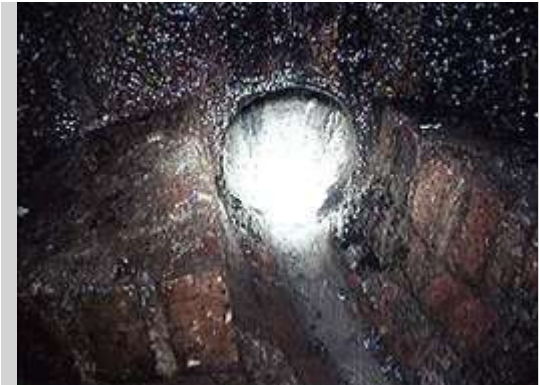
9 O'Clock Inflow

Infiltration: **Evidence** Pipe Seal Cond: **Unknown**
